NASA TECHNICAL MEMORANDUM

NASA TM X-64846

MSFC SKYLAB ATM CALIBRATION
ROCKET PROJECT

Skylab Program Office

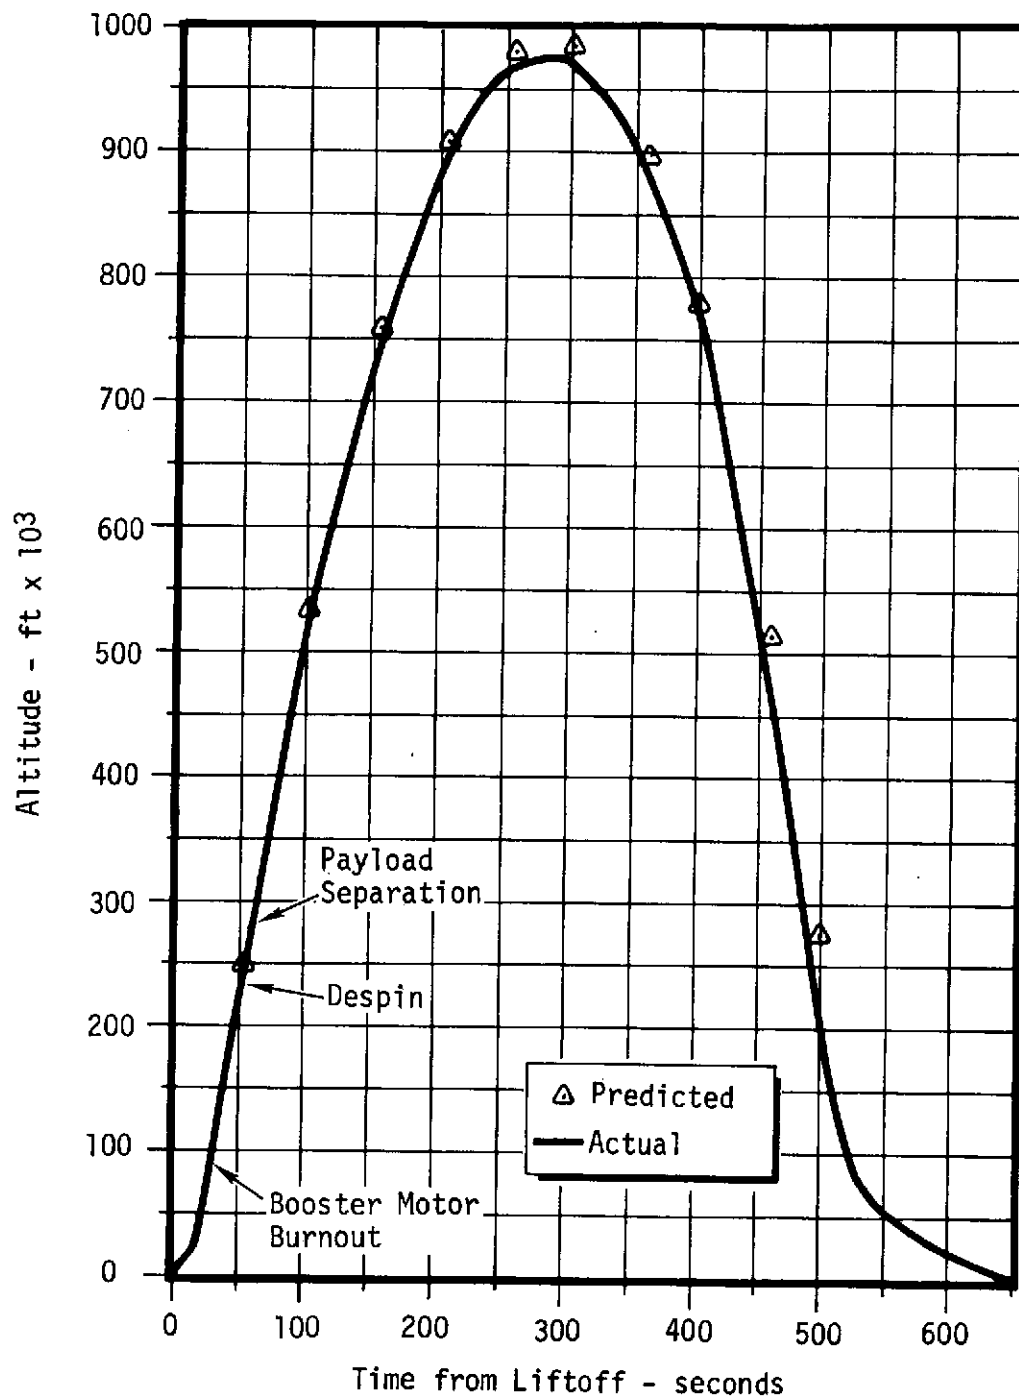
Figure 4-1. Payload 21.007 Altitude History

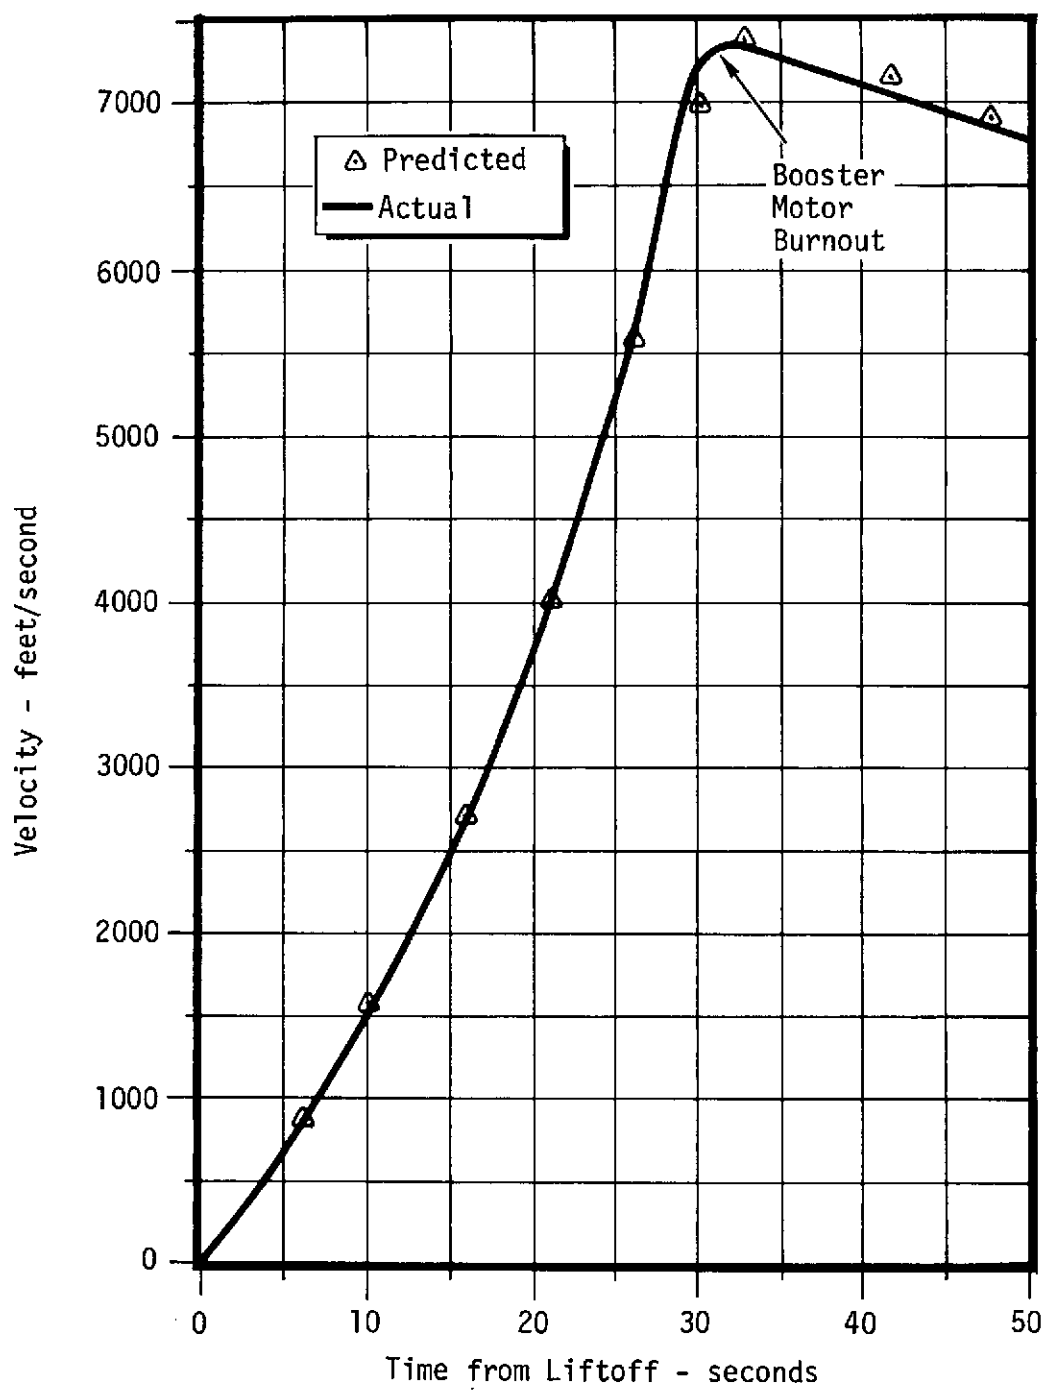
Figure 4-2. Payload 21.007 Velocity History

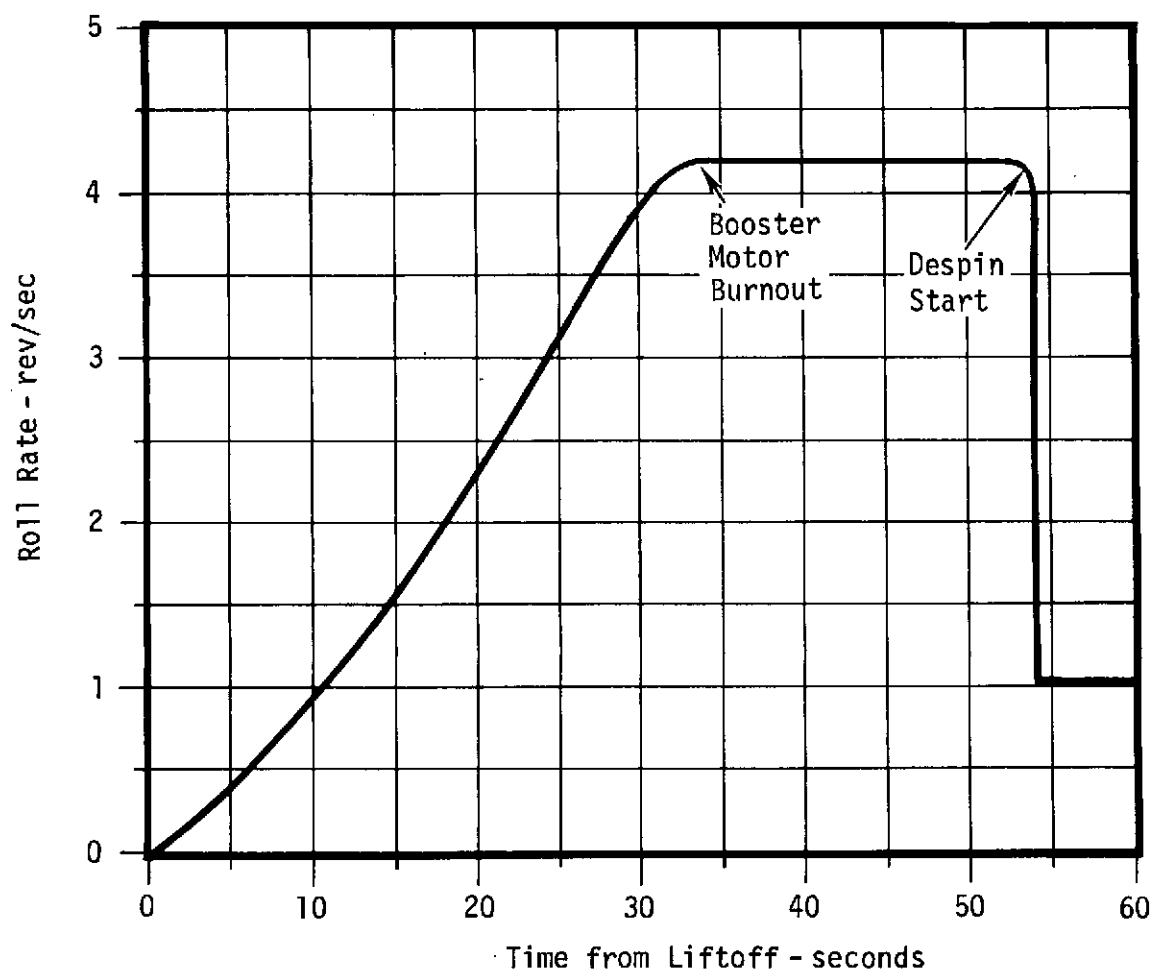
Figure 4-3. Vehicle 21.007 Roll Rate History

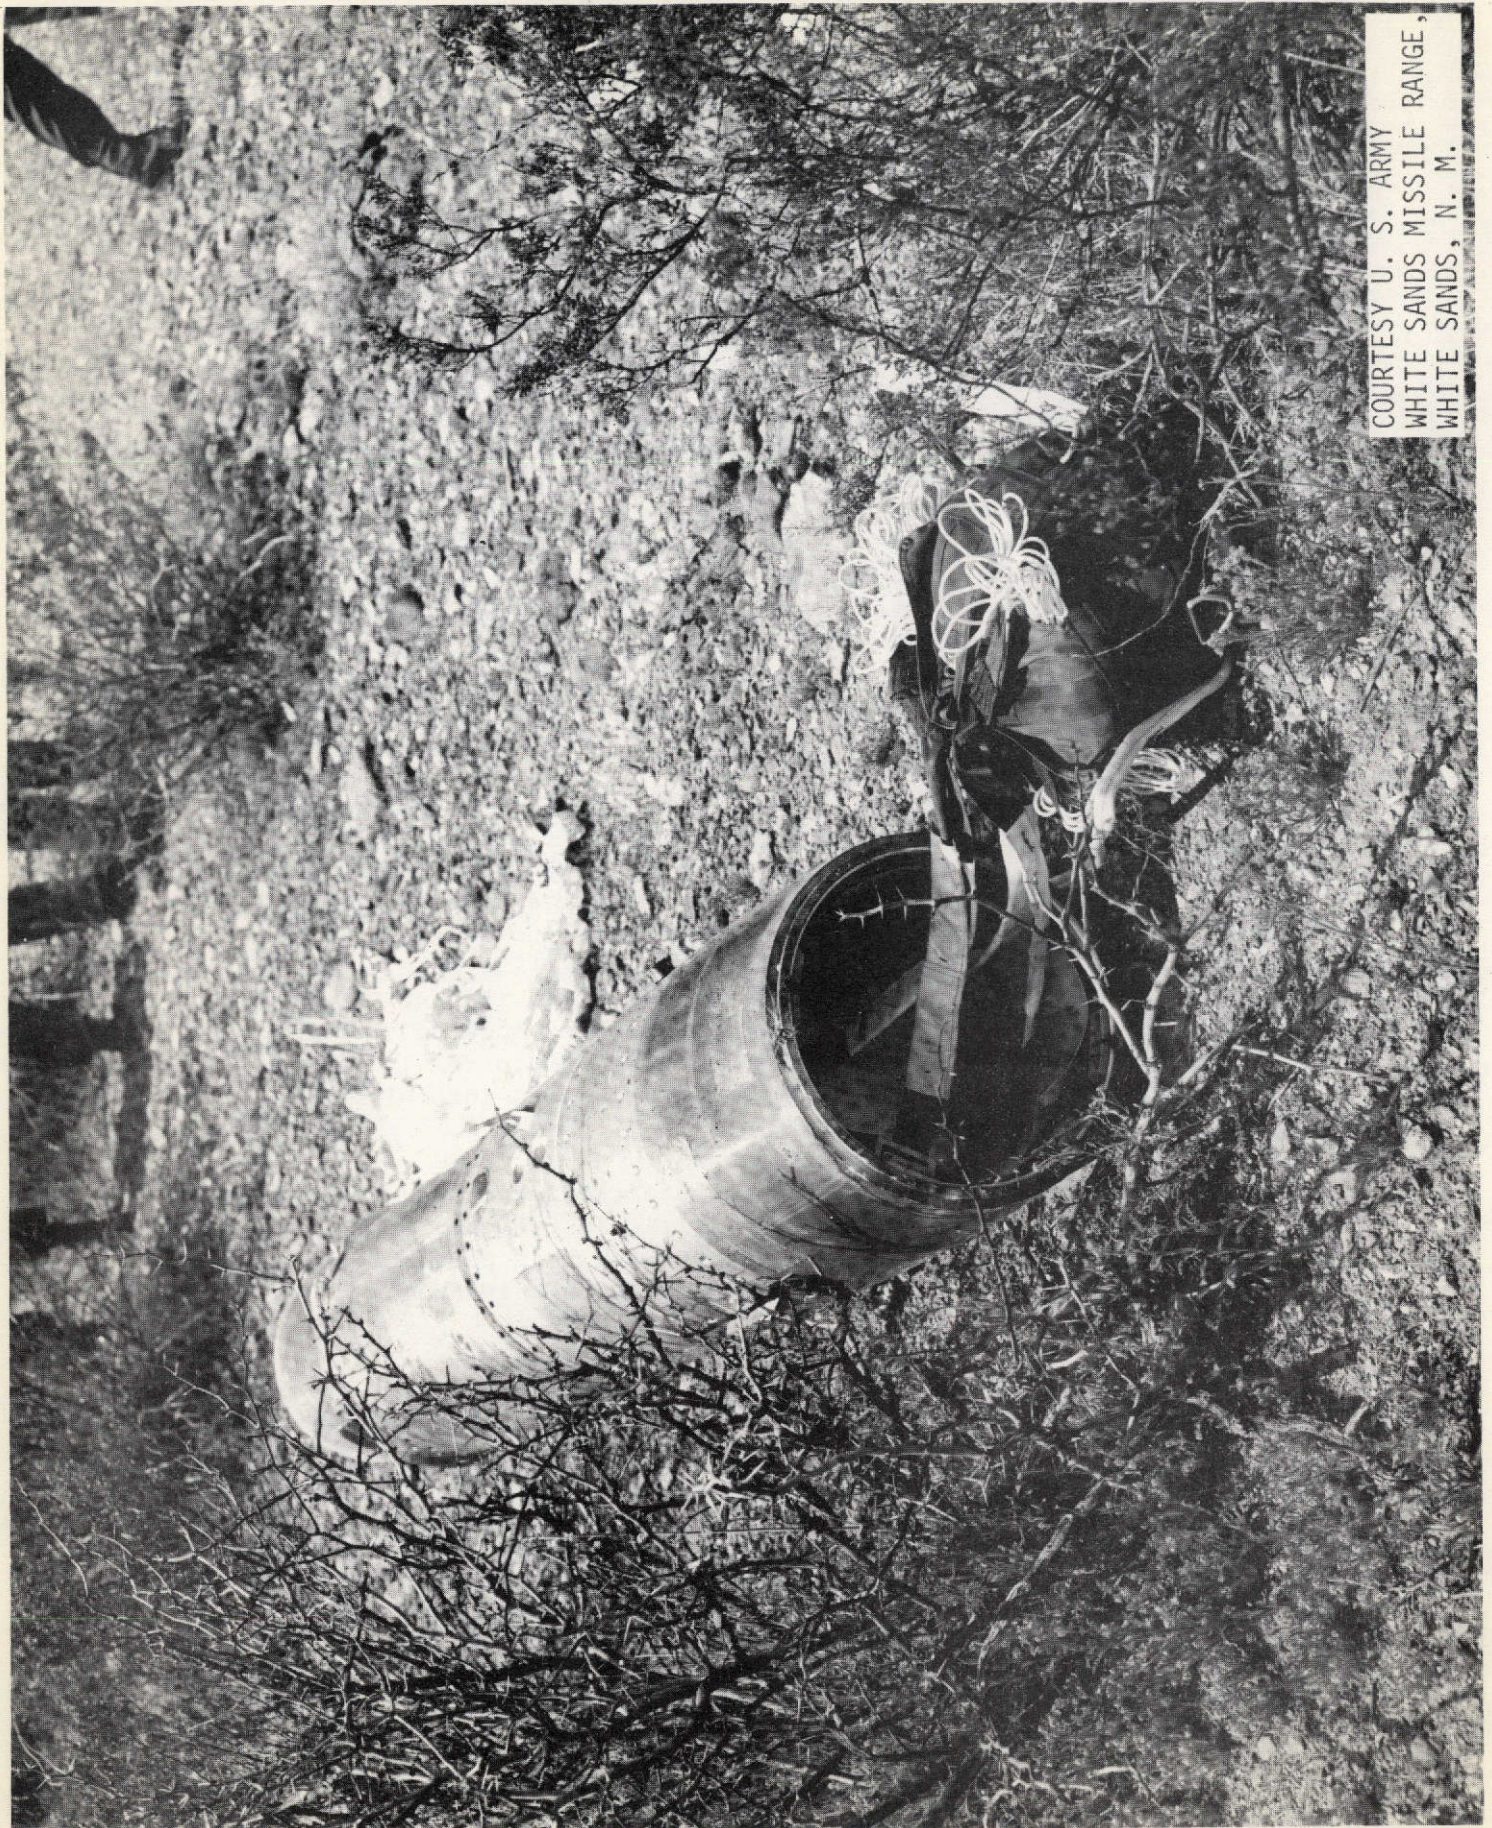
The cause of the Recovery system failure was immediately apparent upon examination of the parachute assembly as it lay on the desert (Figure 4-9). The main parachute was contained in a canvas bag which was closed by four flaps and secured by a bight (loop) of one of the main risers. Excessive friction between the main riser bight and the mouth lock retaining loop pulled the innermost mouth flap through holes in the other three flaps, relocking the mouth lock after the riser line bight had finally pulled free. As a consequence, the main parachute was never deployed, and the only decelerating force, which was too small to be effective, came from the captive drogue chute.

Figure 4-9. Post-Flight NRL CALROC 21.011 Payload.

Because of damage to the four main risers on previous Black Brant flights due to sharp edges of a rapidly rotating canister assembly, protective leather chaffing strips had been sewed to the main risers. This modification had been successfully demonstrated in a drop test, and during the flight of CALROC test flight 21.009. This NRL CALROC flight was the third application of this modification, and proved it to be unreliable. The additional bulk of the leather on the bight, coupled with increased friction, and holes too large in the other three mouth flaps, distorted the mouth lock assembly and caused the bottom flap to be pulled through the other three flaps and relock the main parachute bag. Impact damage throughout the payload was so extensive that refurbishment was not possible. The payload was disassembled and parts used for test purposes.

Several significant changes to the CALROC Recovery subsystem were implemented as a result of the 21.011 failure. They were:

- a. Change the main parachute mouth locks from four to eight.
- b. Add a mouth lock cord fed through a loop on each flap and tied.
- c. Add two knife cutters stitched to two risers for cutting the tie cord.
- d. Replace leather scuff guards with less bulky aluminized asbestos on both main risers and drogue bridle.
- e. Accordion fold the drogue tow line.

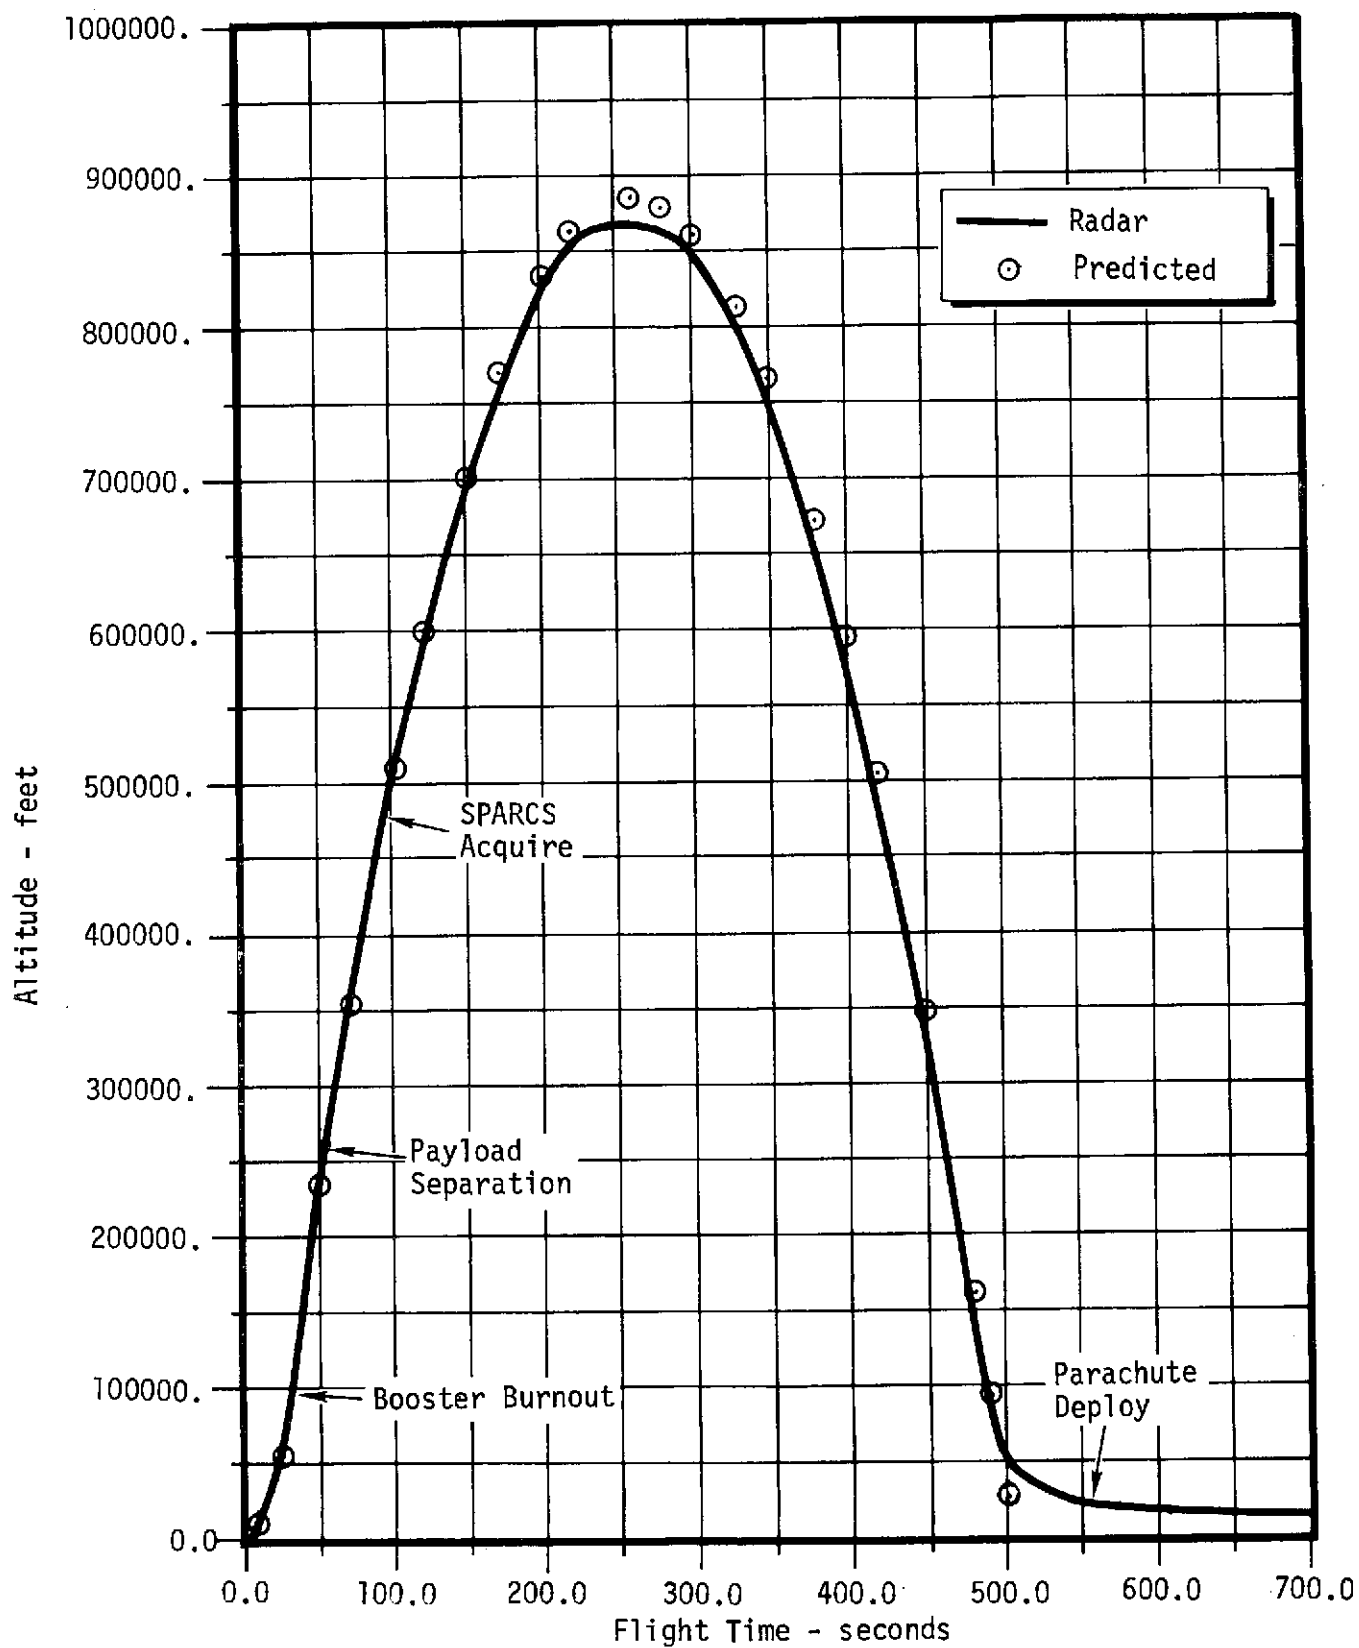
Data in Table 4-2 and Figures 4-10, 4-11 and 4-12 indicate that booster and payload performances were near the preflight predicted values.²⁰ Booster burnout occurred 1.4 seconds early, resulting in a

Figure 4-10. BBVC Flight 21.019 Altitude History

lower than expected burnout velocity, burnout altitude, apogee time and apogee altitude. The apogee altitude was within 1.79 percent of predicted, which was well within the three-sigma apogee dispersion (± 6 percent).²¹ Table 4-2 and Figure 4-13 indicate timely separations and a better than expected time for sun acquisition (95 seconds versus 103 seconds predicted).

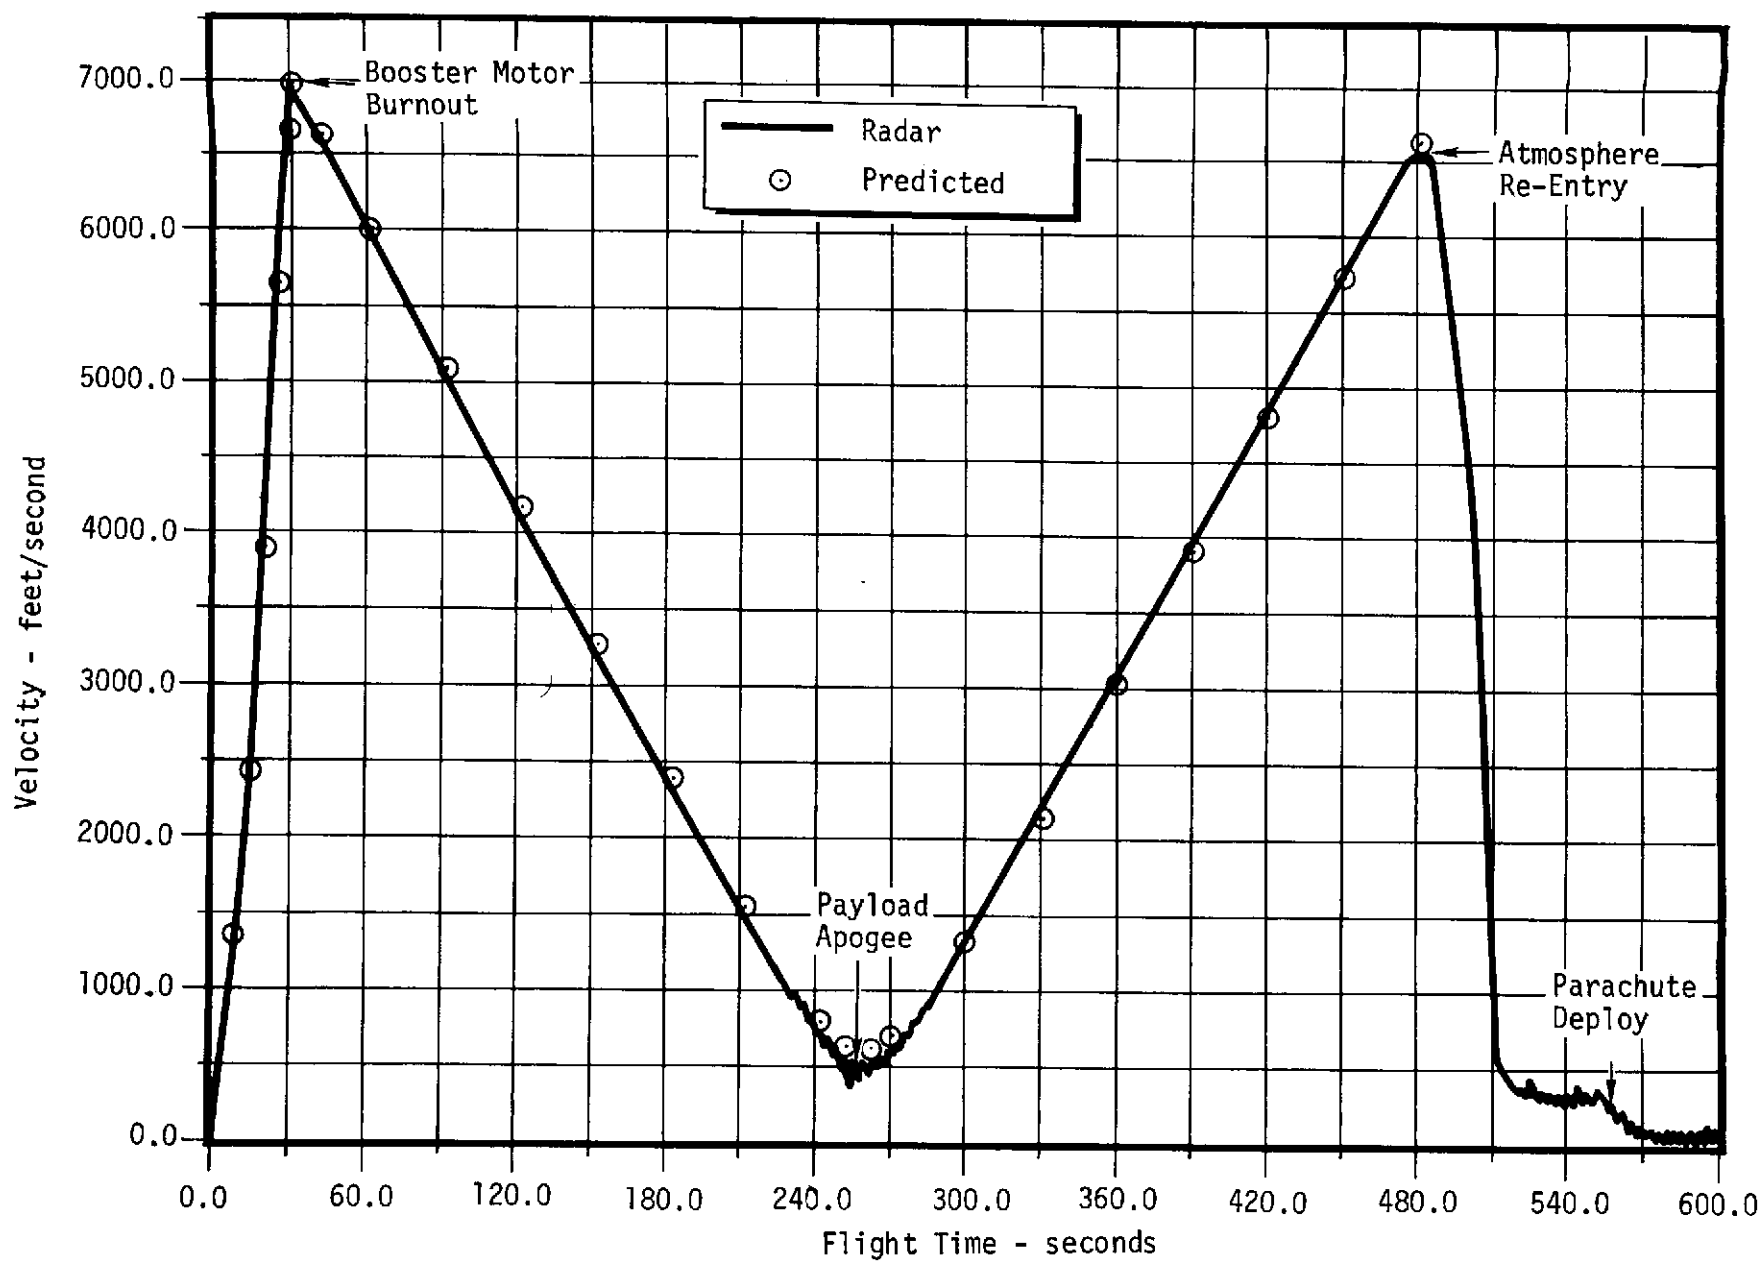
Figure 4-11. BBVC Flight 21.019 Velocity History

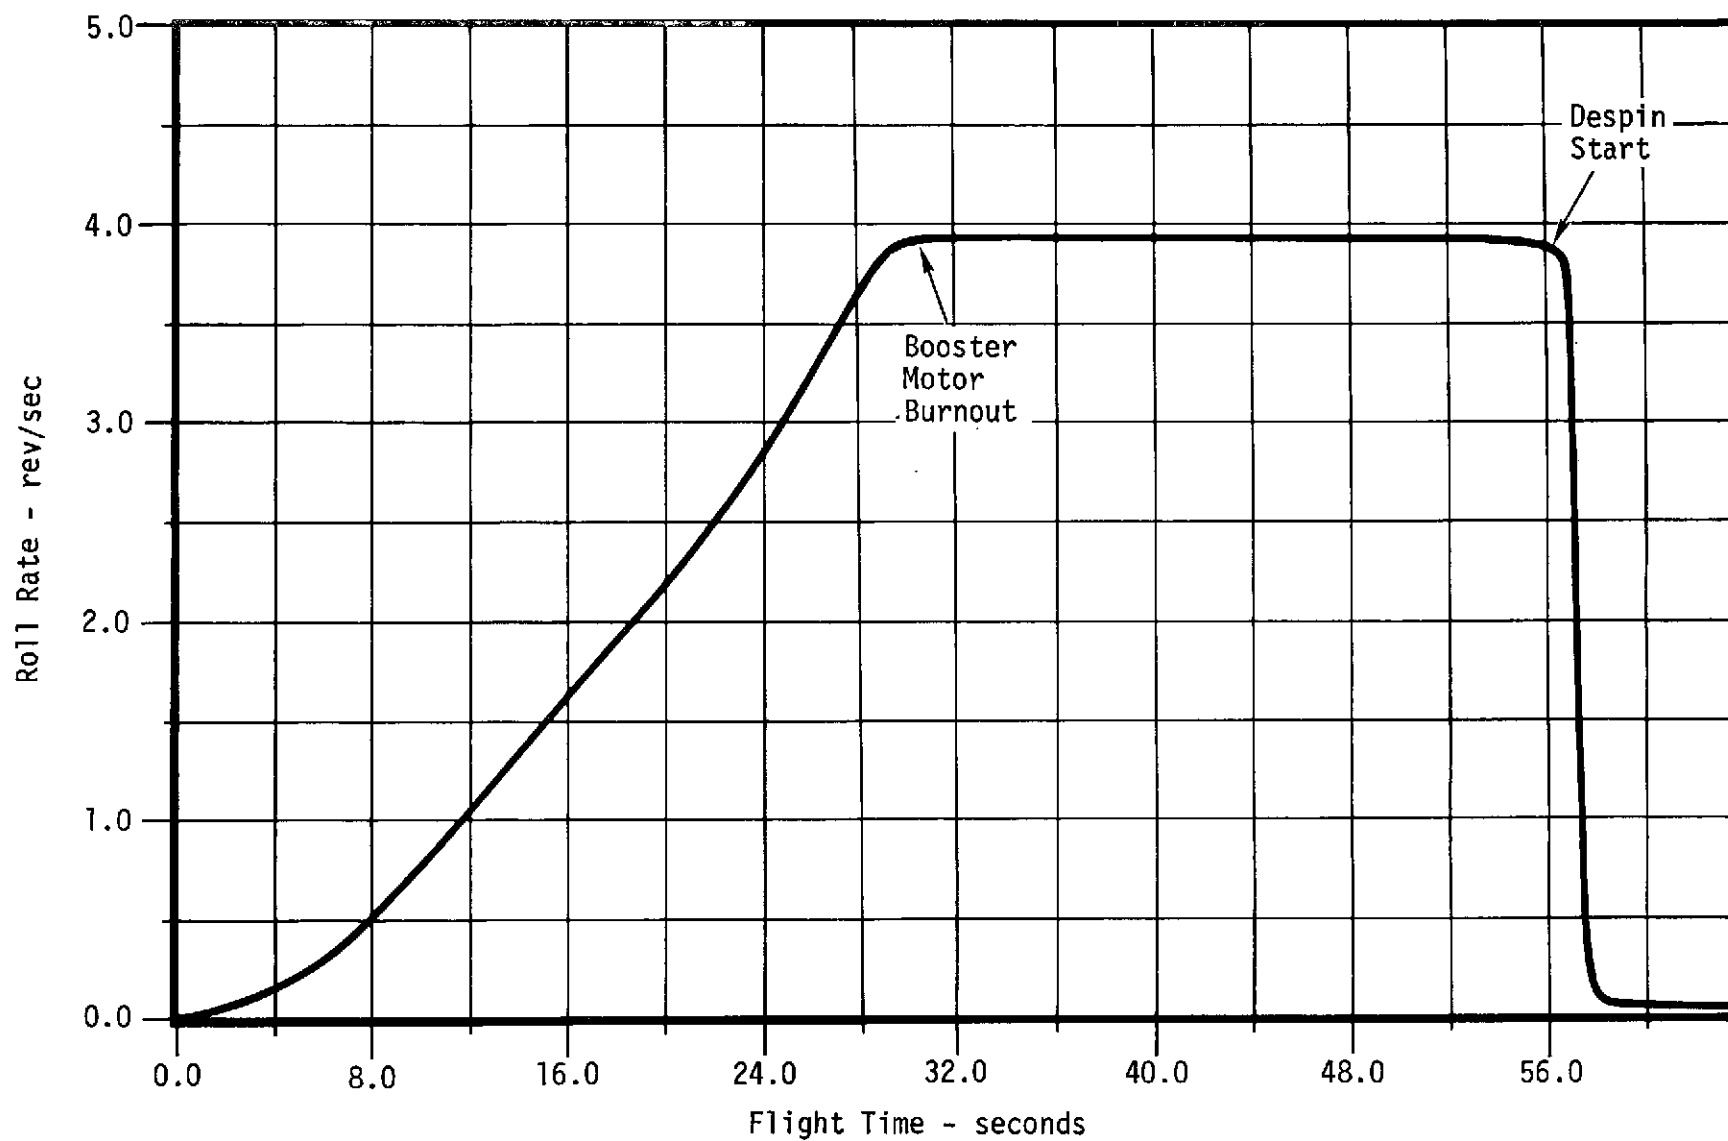
Figure 4-12. Flight 21.019 Roll Rate

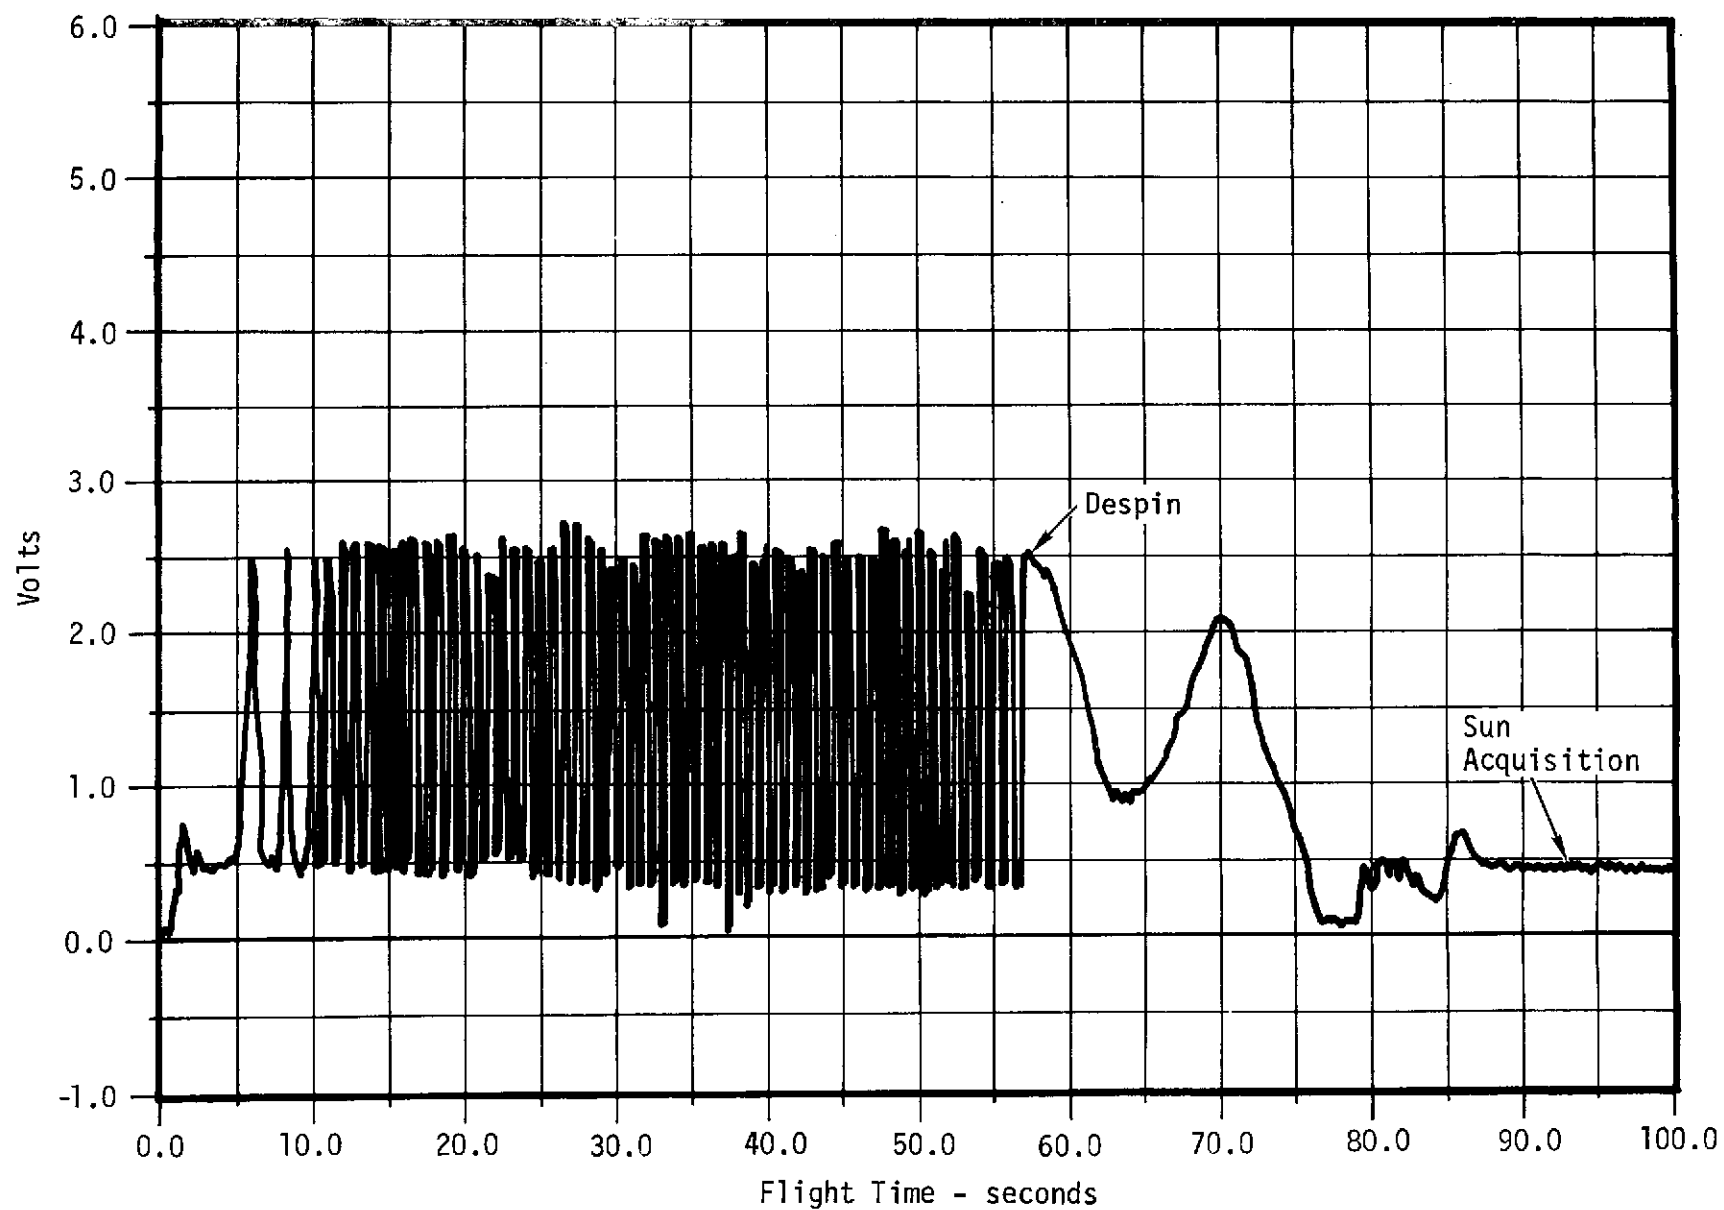
Figure 4-13. Flight 21.019 Yaw Coarse Solar Sensor Output

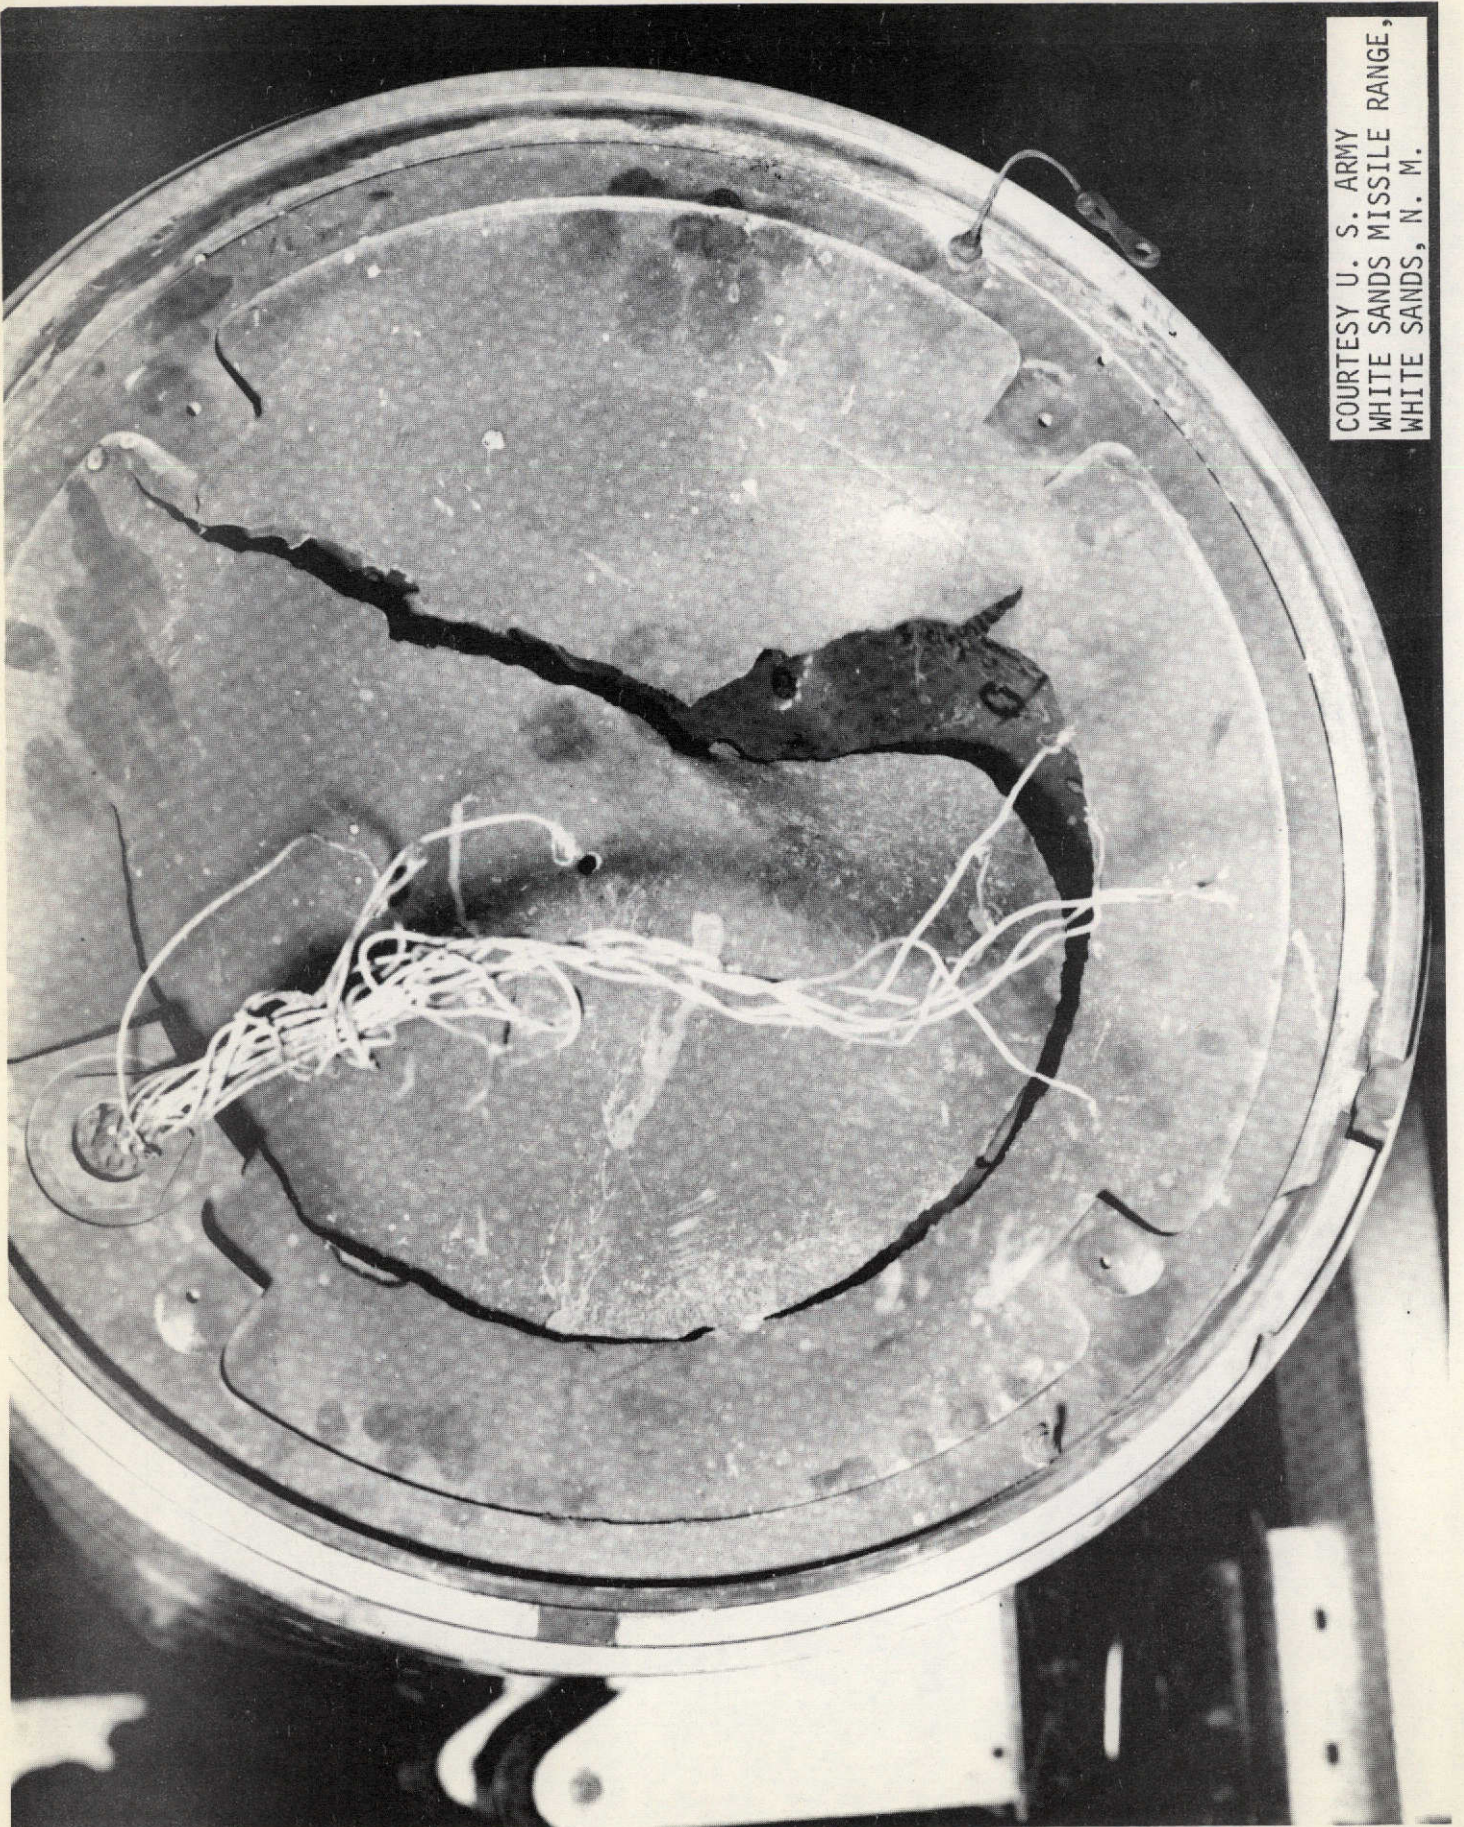
Figure 6-2. Post-Flight HCO CALROC 21.021 Payload, Vacuum Dome Rupture.

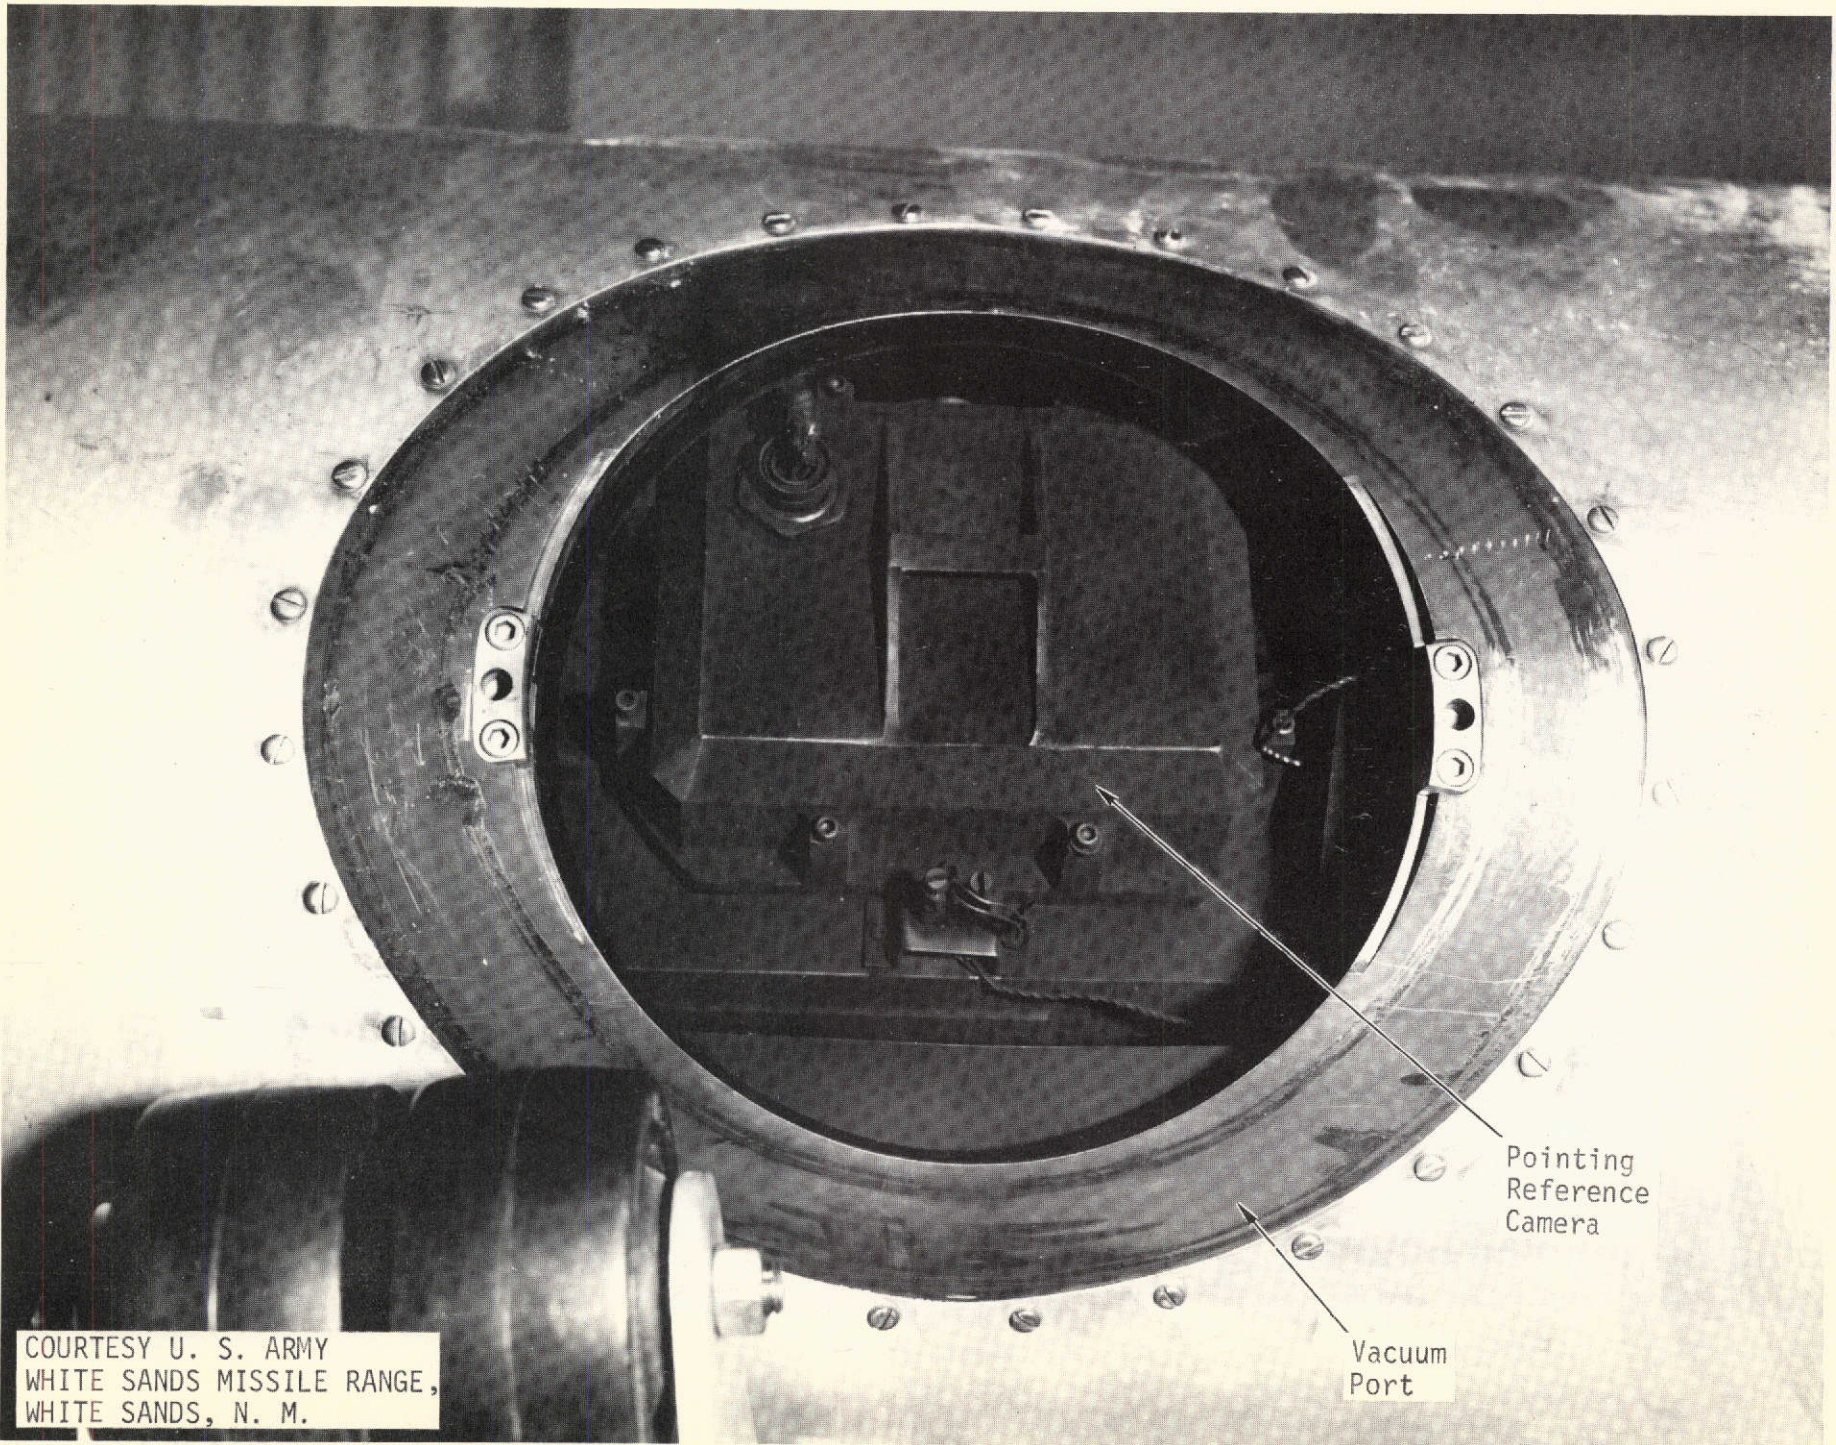
Figure 6-3. Post-Flight HCO CALROC 21.021 Payload, Carbon Deposit Seen thru Vacuum Door.

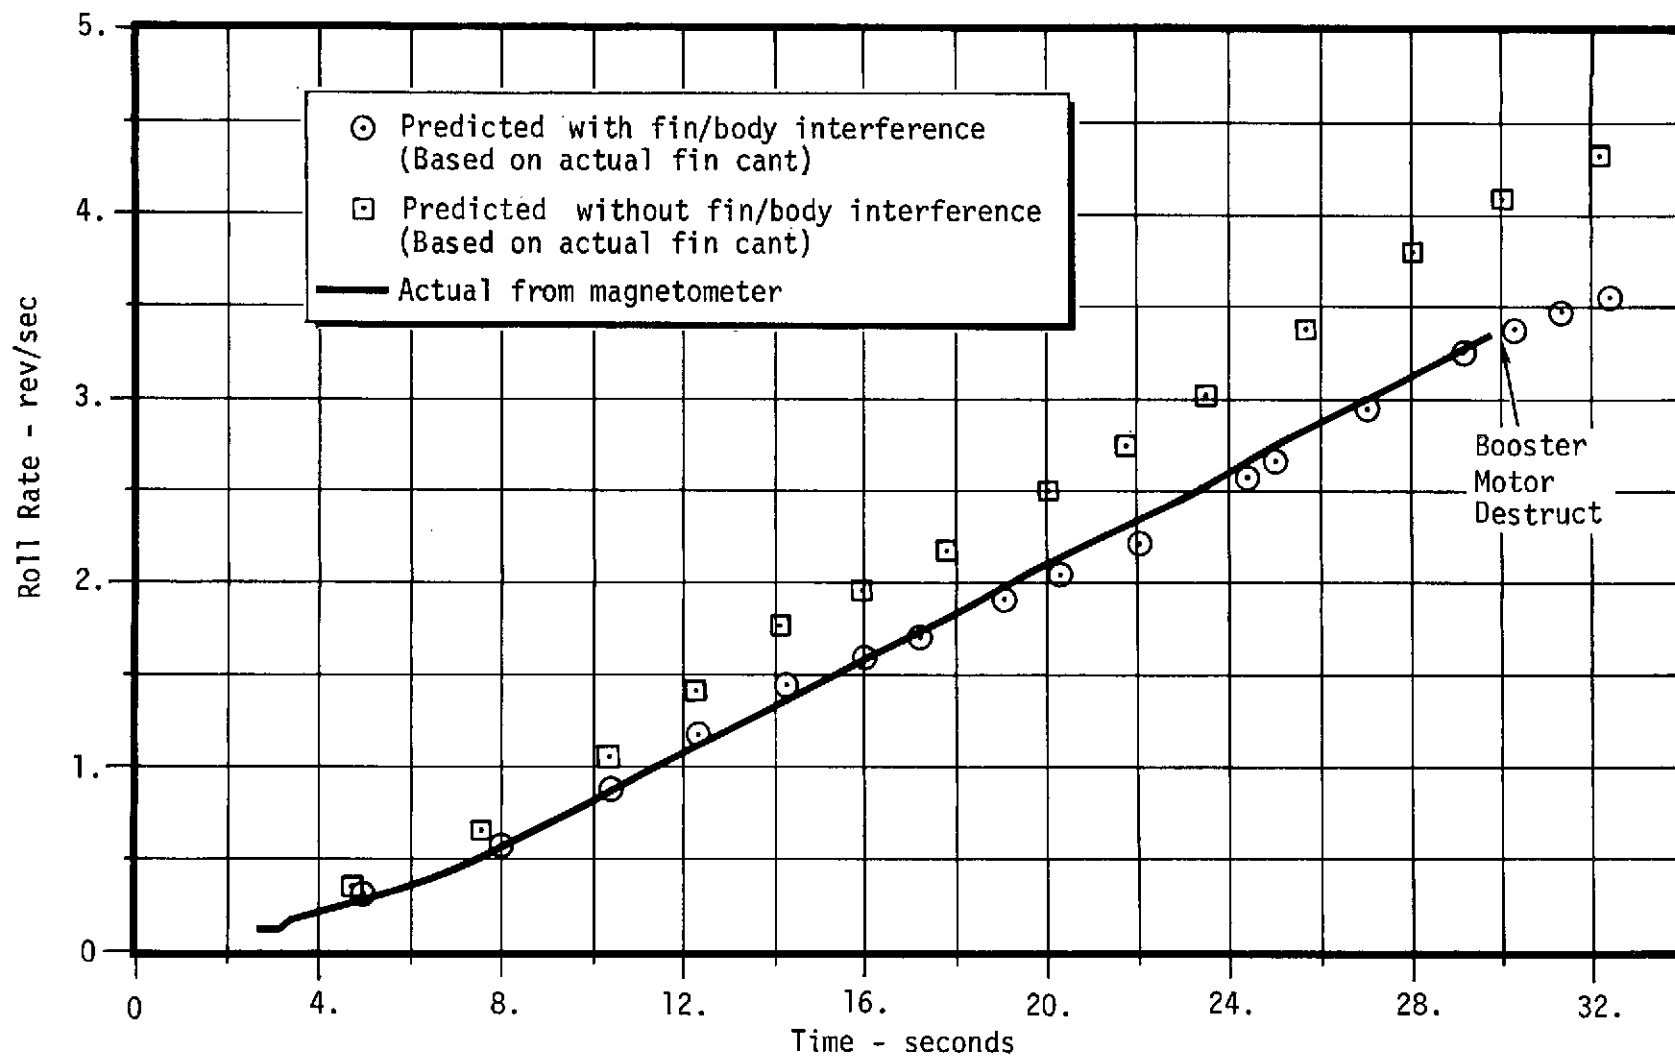
Figure 6-7. Roll Rate versus Time from Lateral Magnetometer -- Flight 21.021
